TURBOCHARGER WARRANTY ANALYSIS GUIDELINES

AUTHORIZED AGENT USE ONLY

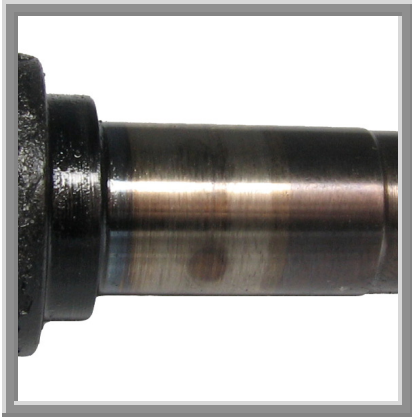
- Low engine oil pressure/level
- Obstructed oil supply / drain lines
- Improper weight of oil
- Contaminated oil
- Fast starts in cold weather
- Hot shutdown (**Figure 6**) - *Engine is shutoff at high rpm/temp; instant oil flow loss causing overheating*
- Engine Blow-by

Figure 6: "Hot Shutdown"
Turbine Wheel Shows Visible Bearing Pattern and Heat Discoloration

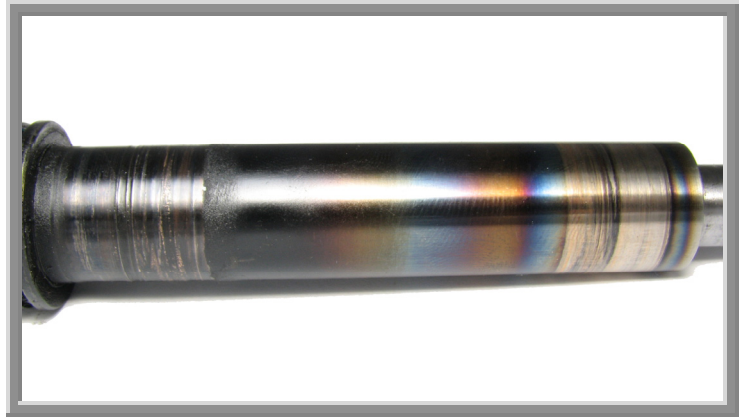
- Occurs when anything exterior to the turbocharger is affecting the oil flow (supply or drain lines, engine blow-by, etc.).
- All thrust & journal bearings as well as the turbine shaft will show signs heat discoloration (**Figure 7**) as well as wear from the resulting shaft motion. The wear will appear smooth or “wiped” (**Figures 8 & 9**) and should not have any significant scaring (**Figures 10 & 11**).
- Unwarrantable: The cause of this failure is external to the turbocharger.

Figure 7: Turbine Shaft Lack of Lubrication
Turbine Wheel Shows Visible Heat Discoloration and Smeared Wear

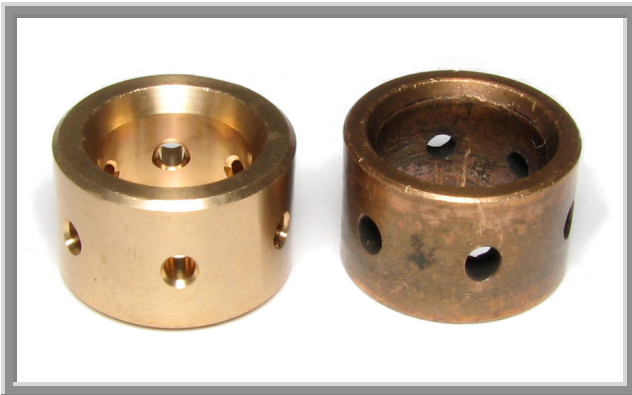
Figure 8: Journal Bearing Lack of Lubrication
Left = New Bearing; Right = Smooth Wear & Heat Discoloration

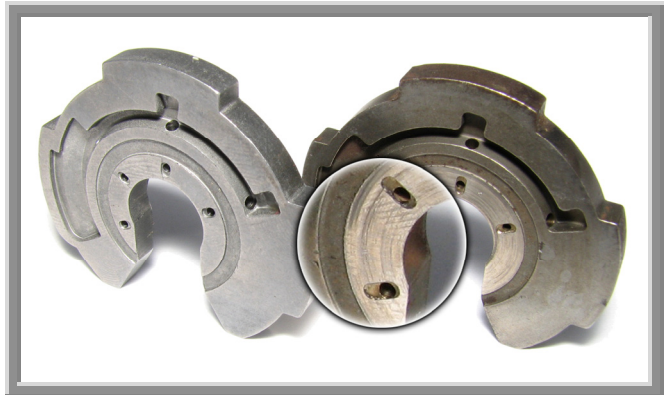
Figure 9: Thrust Bearing Lack of Lubrication
Left = New Bearing; Right = Smooth Wear & Heat Discoloration

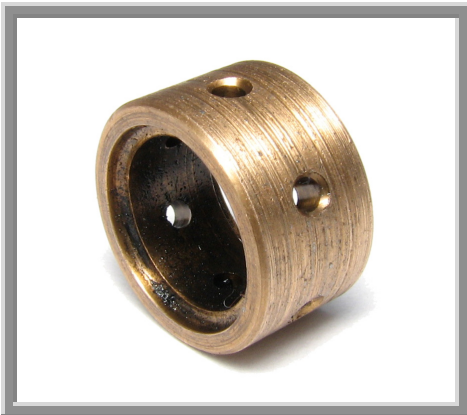
- Occurs when abrasive material such as dirt, sand, or metal shavings enters the oil passages. This is generally easy to notice as the bearings and connecting components will show abnormal grooves and scratches (**Figures 10 & 11**). This may also cause a lack of lubrication failure as noted above.
- Unwarrantable: The cause of this failure is related to the installation or oil quality within the vehicle.

Figure 10: Journal Bearing Contaminated Oil
Visible Scarring on Inner and Outer Diameters

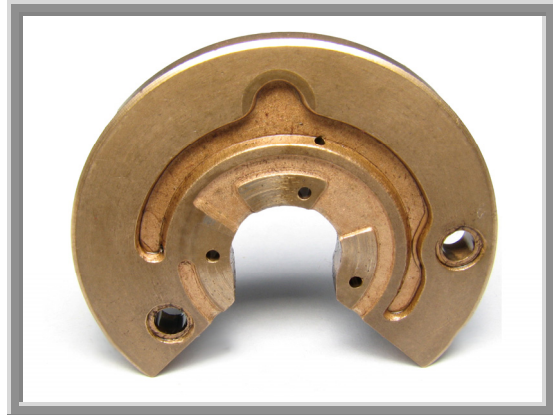
Figure 11: Thrust Bearing Contaminated Oil
Visible Scarring on Pads

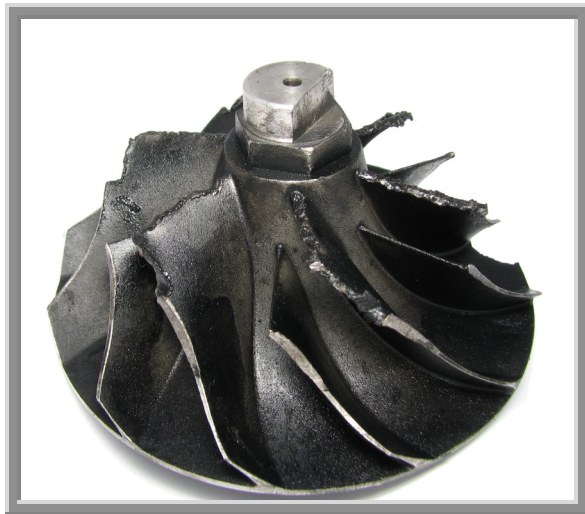
In many cases, this is the most obvious damage to recognize as the compressor or turbine wheel will often show severe damage without removing the housing (**Figure 12 & 13**). However, in some scenarios, this is a gradual erosion of the wheel from fine particles such as sand or dirt. In this case, the wheel will display small pits across the vanes or minor wear on the inducer tips.

Figure 12: Compressor Wheel Foreign Material
Severe Damage to the Vanes on the Wheel

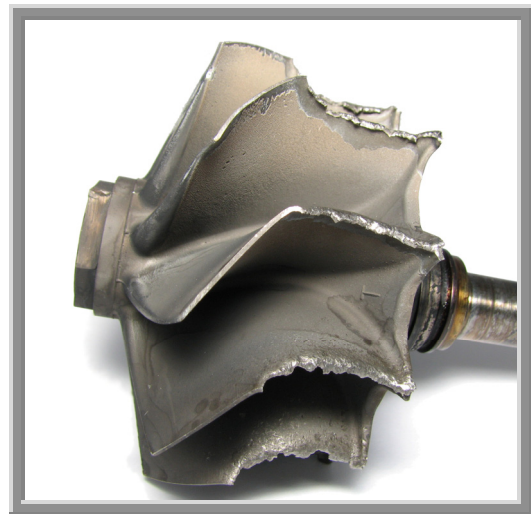
Figure 13: Turbine Wheel Foreign Material
Severe Damage to the Vanes on the Wheel

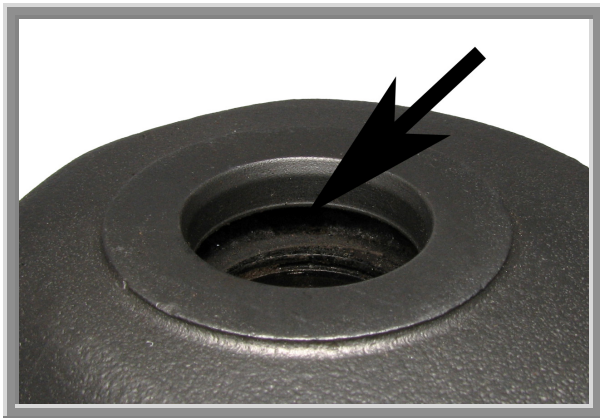
Excessive temperature in the exhaust system will cause the lubricating oil to “coke” in the bearing housing drain annulus at the turbine end (**Figure 14**). This causes oil leakage into the turbine housing. Coke and carbon deposits will be visible and eventually damage the back of the turbine wheel and cause abnormal wear on the thrust bearing. High exhaust temperatures can also erode (**Figure 15**) and crack (**Figure 16**) the turbine housing and/or bearing housing. Excessive heat discoloration of the turbine shaft is usually visible. The piston ring in the turbine side of the bearing housing will often appear relaxed if it has been submitted to these high temperatures.

Figure 14: Bearing Housing High Exhaust Temp
Blocked Drain Annulus from Oil Coking

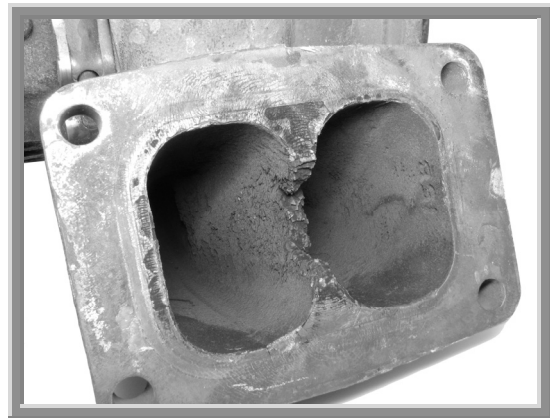
Figure 15: Turbine Housing High Exhaust Temp
Erosion of Web Caused by High Temperatures

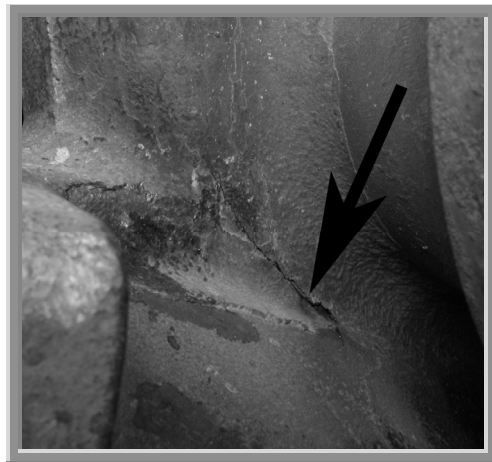
Figure 16: Turbine Housing High Exhaust Temp
Cracked Housing Caused by High Temperatures

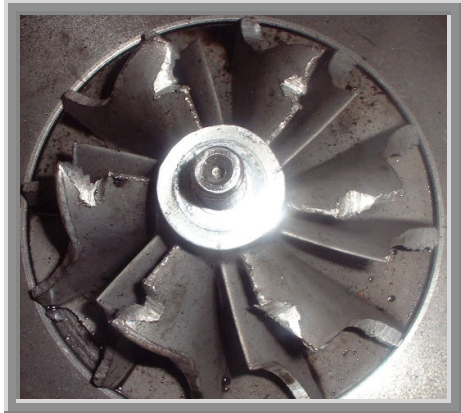
Although rare, this failure may also be caused by the compressor wheel lock nut loosening off and entering the compressor vanes (**Figure 17**). This failure originates from assembly if the lock nut was not tightened to the specified torque setting or the Loctite® compound was not applied.

Figure 17: Compressor Wheel Lock Nut Failure
Nut is missing, foreign object
Damage to vanes

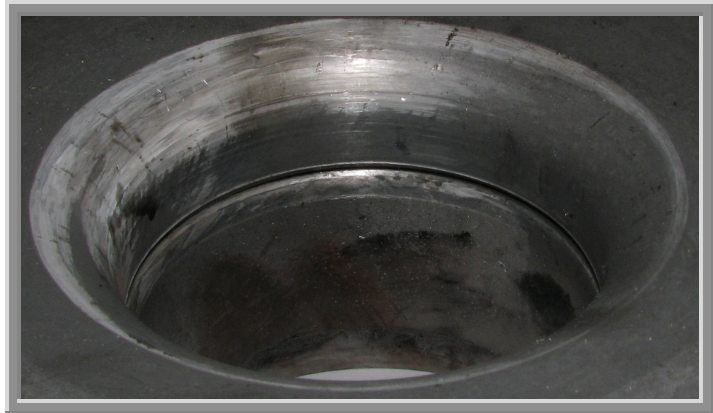
Figure 18: One Sided Wear on Compressor Housing
Can be caused by improper manufacturing or assembly

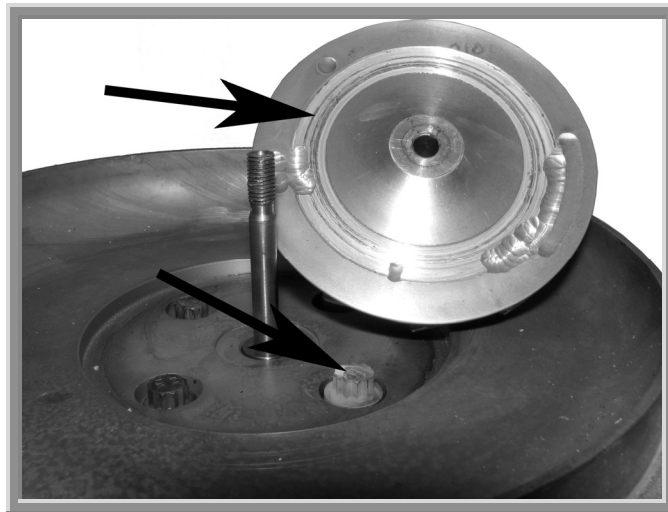
Figure 19: Back Plate Bolt Loosened and Contacted Back of Compressor Wheel
Can be caused by improper assembly (No Loctite®)

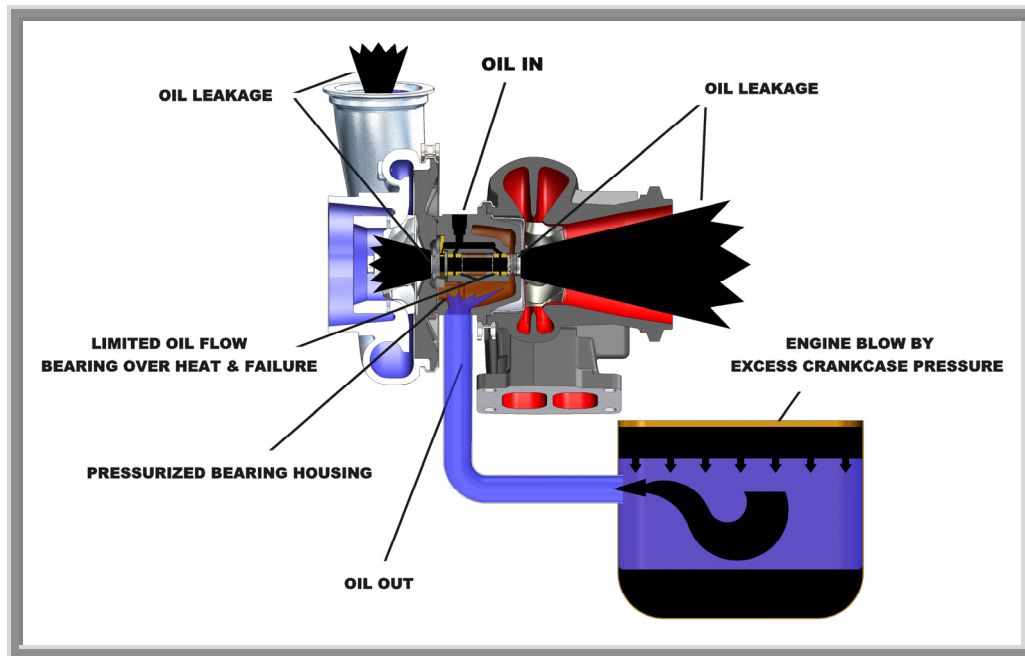
Figure 20: Engine Blowby

Increased crank case pressure causes flowing oil to squeeze out of the piston ring gaps and also reduces the amount of oil flow to the bearings causing failure

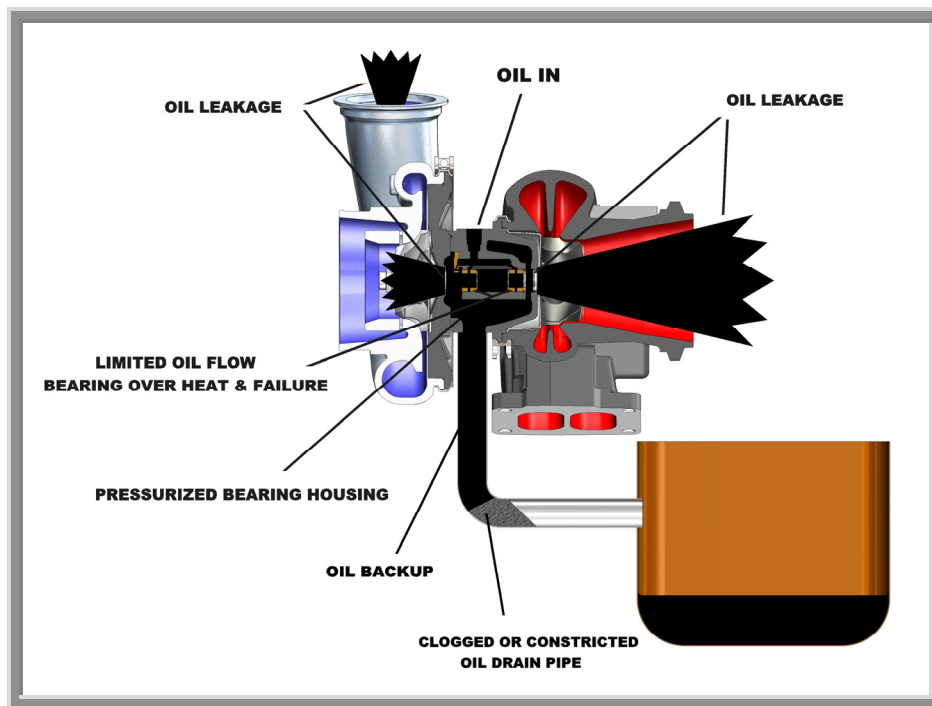
Figure 21: Clogged Oil Drain Pipe

Oil cannot flow and pressurizes the drain area causing oil leakage and bearing failure

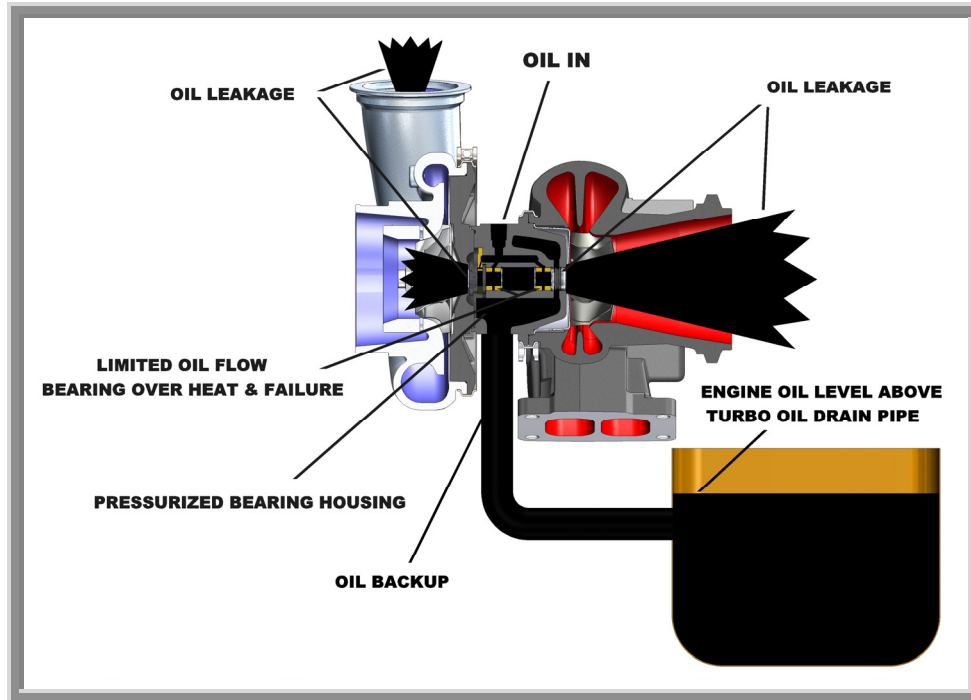
Figure 22: Oil Level Too High

Any minor pressure in the crank case will prevent oil from flowing which pressurizes the drain area causing oil leakage and bearing failure

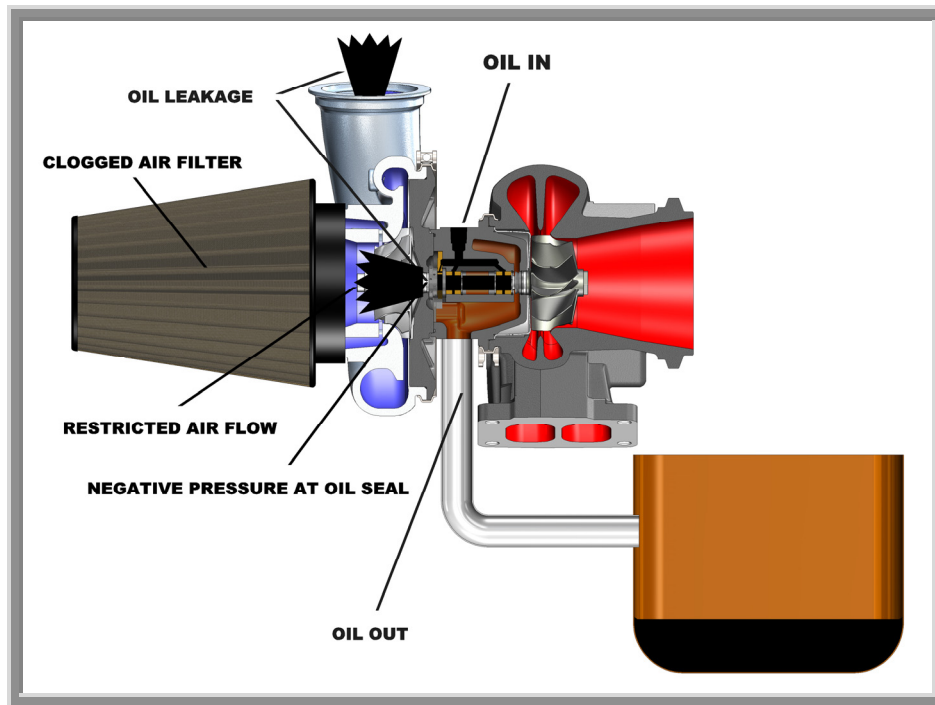
Figure 23: Clogged Air Filter

Reduced air flow in the compressor inducer will create high vacuum area which will pull oil into the compressor side of the turbocharger
