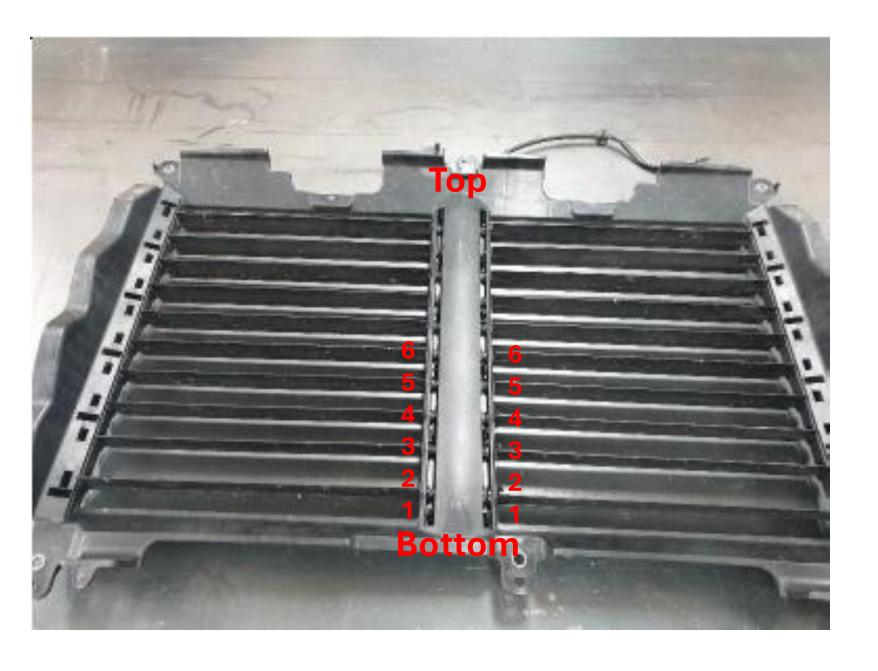
Counting up from the bottom, remove fins 4 & 5 from both sides

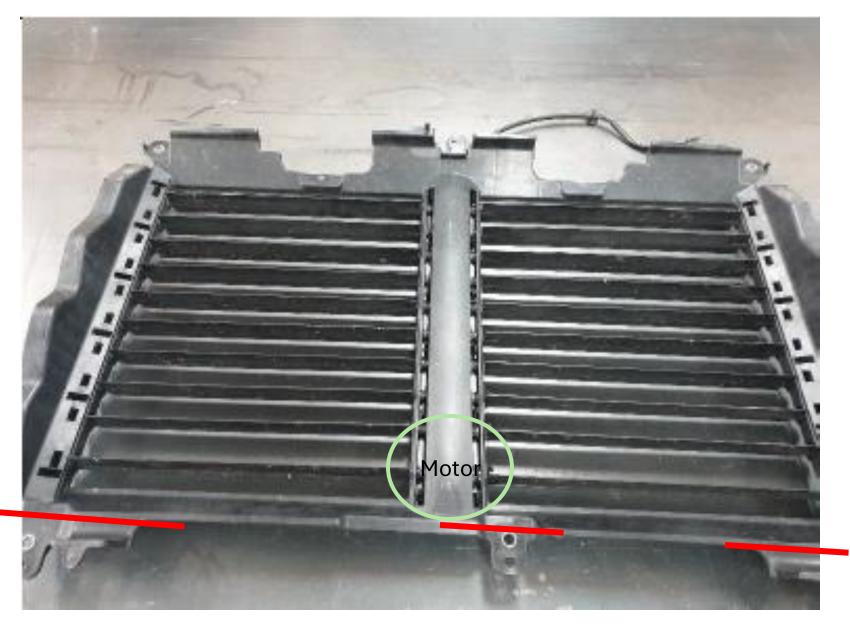
IF required, trim off the lower mounts for additional clearance, shown in RED

NOTE: Make sure motor assembly is NOT modified.

Motor is in the center of the shutter assembly (as marked in green)

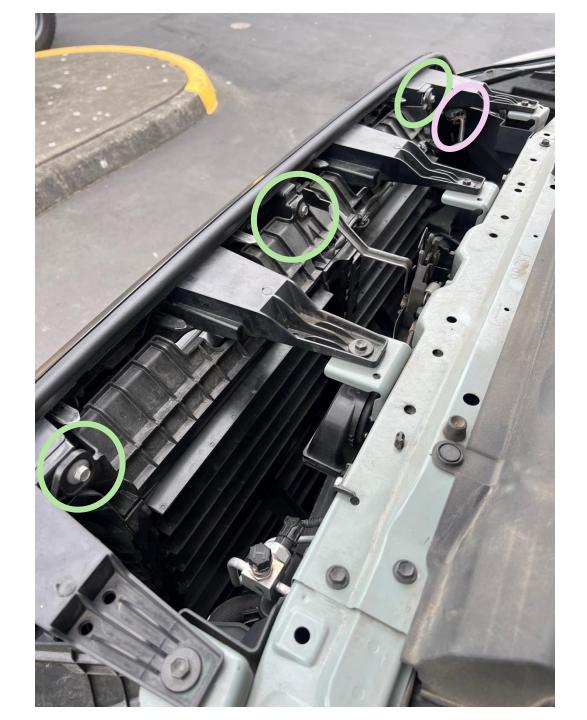
Reinstall the shutter assembly, using the factory three mounting locations at the top of the grille. Ensure connector is reconnected.

Fit should be tight, however it's recommended to use zip ties to secure bottom of assembly.

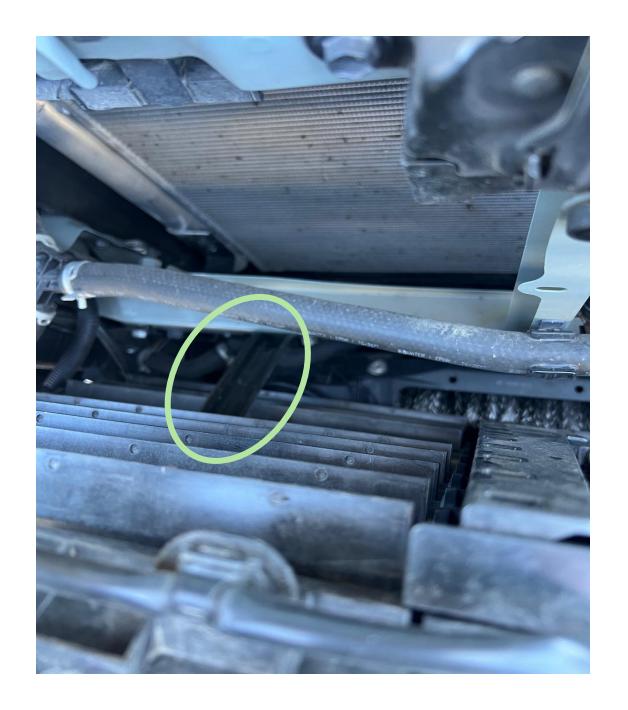
Ensure clearance of the grille supports through the shutter assembly
