MQB Coolant Ventilation Union

The 034Motorsport Billet Coolant Vent Union is designed to replace the factory plastic and failure-prone coolant union on the cylinder head of the EA888 Gen3 and Gen4 engines. Being next to the turbocharger, the factory plastic coolant union is subject to a lot of heat, becoming brittle and failing over time.

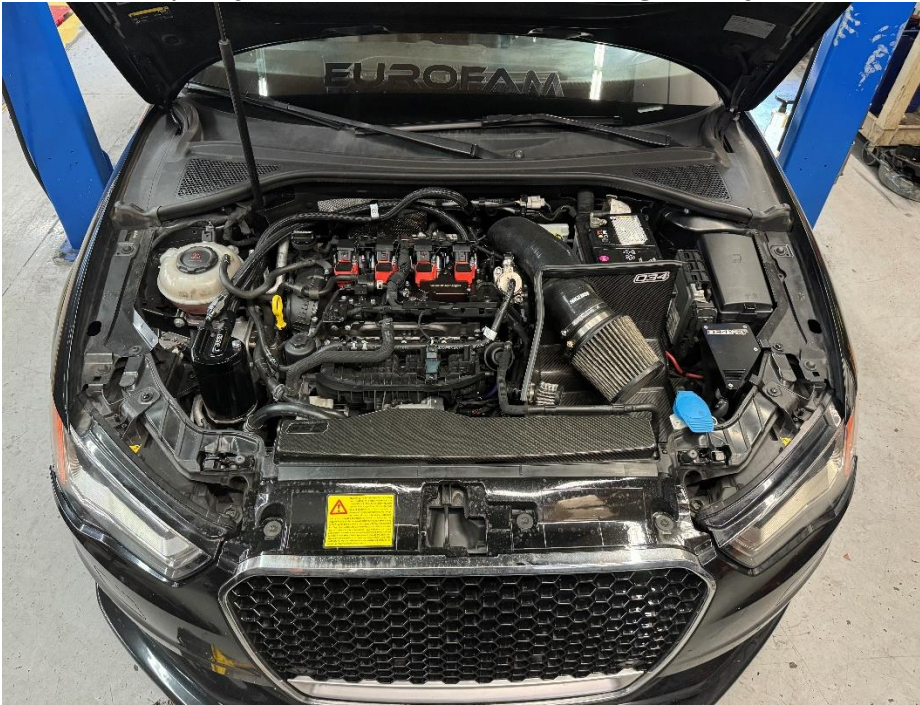
Step 1

Open your hood to access the engine bay.

Many of the steps performed in this installation guide are included to make this installation easier. Please note that the removal of the coolant union is possible without disconnecting sensors and plugs but may be difficult.

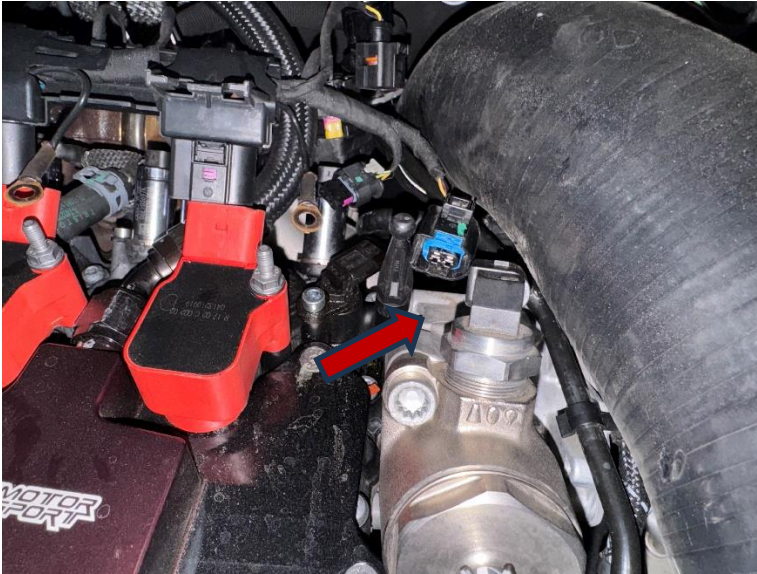
Step 3

Disconnect the HPFP.

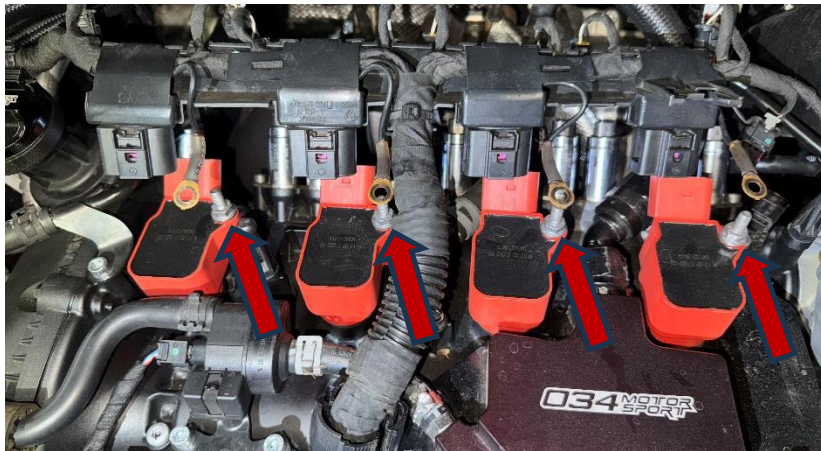
Step 4

Remove the (4) nuts securing the grounding wire to the coil packs with the 10mm socket/wrench. Disconnect the coil pack plugs and lift the harness out of the way.
