# Steeda X5 Ball Joint Installation Instructions 555-8108

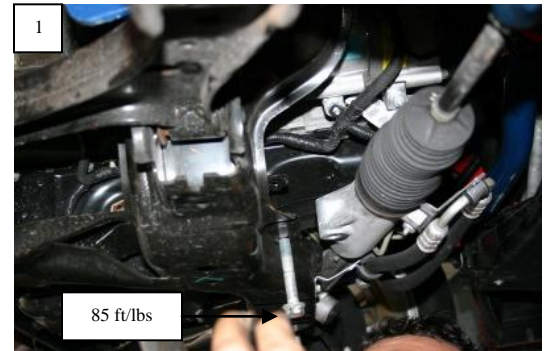
1. Raise the entire vehicle. If working from the floor, secure with jack stands. Remove the two front wheels.
2. Remove the two bolts holding the steering rack to the K-member. This will allow you to move the steering rack and gain access to the front control arm bushing. (Pic. 1)

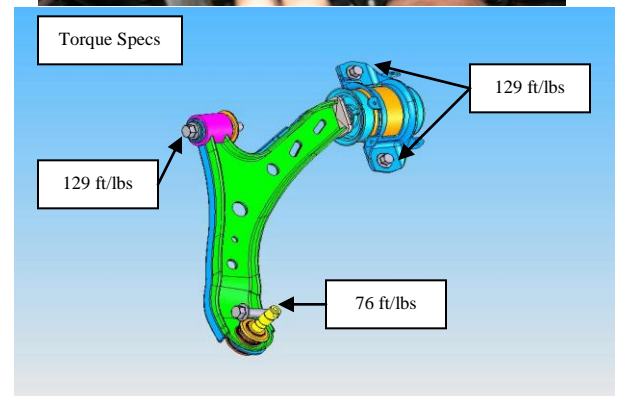
4. Once all bolts are removed, remove the front control arm. Note: It may be necessary to use a pry bar to release the ball joint stud from the clamp. (Pic. 2)
